Kawasaki Heavy Industries, Ltd.

Notice of Series N700 Shinkansen Train Bogie Frames matter

Series N700 Shinkansen Train Bogie Frames

Explanatory Material for Manufacturing of Bogie Side Frames for Series N700 Shinkansen

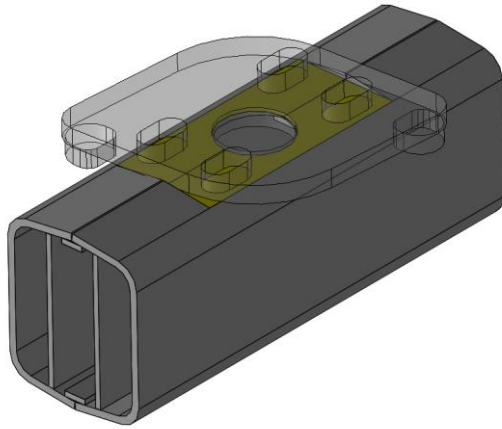
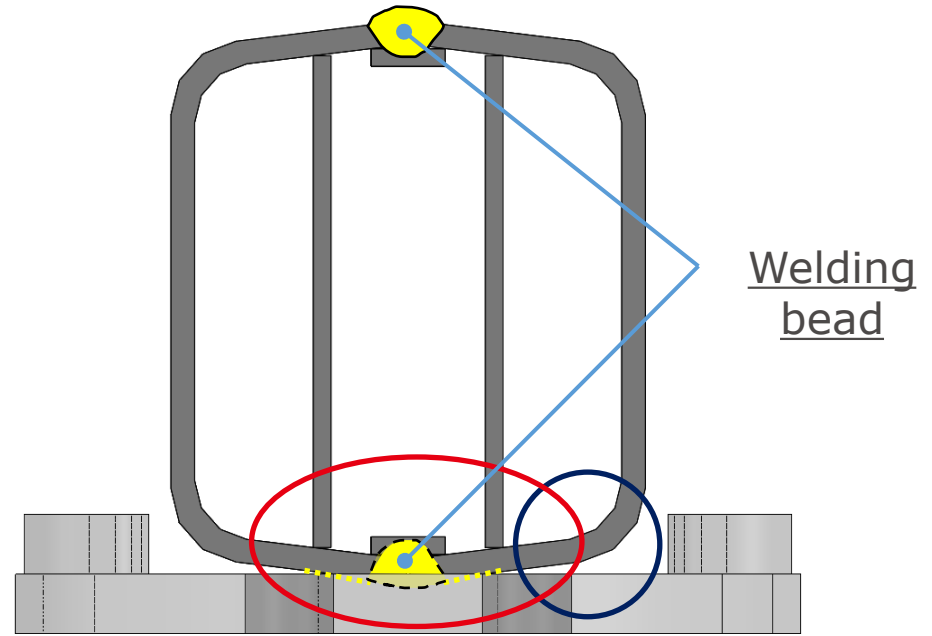
Area of adjustment

- (1) Although the bottom plate of the side frame of the bogie frame of series N700 Shinkansen train should be 8mm thick the design specifications (more than 7mm post-processing), it is 4.7mm at the thinnest location. The results of our internal investigation reveal that in order to adjust the gap between the side frame and the primary spring seat during the welding assembly, the uneven bottom plate of the side frame was excessively ground off, resulting in thinner than 7mm.

When the primary spring seats were attached, the bottom plate of side frame was not even and was ground off to adjust the gaps between the side frame and the primary spring seat to 0.5mm.

As a result, the side frame became thinner.

- (1) Regarding the series N700 bogie frames that we manufactured to the same specifications as the Failed Bogie Frame, we will replace the bogie frames with thinner the bottom plate of the side frame less than 7mm in thick with new ones. We will also replace the bogie frames where, as a result of ultrasound testing, there might exists an internal flaw in consideration of our defects during manufacturing process.
