## STEERING GEAR SERVICE NEWS

No.: E8-18-006

**SUBJECT : Case Example of Steering Disable Due to Drop-off of PIN in M-type Steering Gear**

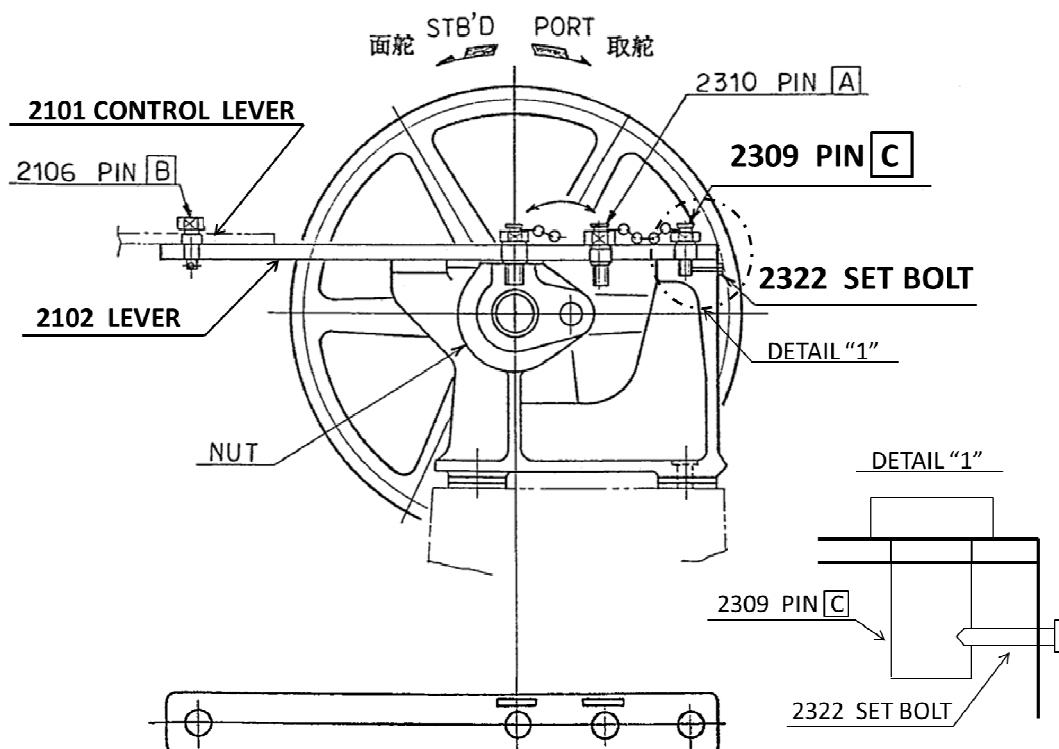
There is a case of an unsteerable vessel where the loosening and falling of the symbol 2309 PIN [C] in the steering gear of the type RM/FM caused the interference between the symbol 2101 CONTROL LEVER and the symbol 2102 LEVER, which prevented the CONTROL LEVER from functioning properly. Generally, drop-out prevention measures are taken against PIN [C] using the symbol 2322 SET BOLT, however, the set bolt itself may gradually loosen due to vibration, etc., as a result of long-term use. Reportedly, no inspection for that portion has been executed in the vessel of this example for about seven years after its service.

To secure the safety navigation, please confirm the looseness of the set bolt at the inspection prior to departure and verify the normal operation of the steering gear. Although we believe that the bolt with the present specification is usable without any problem if properly inspected on each occasion, it is possible to replace the part with a hexagon socket set screw to be securely tightened by a hexagonal nut and a spring washer, as an alternative enhancement for safe locking of the PIN [C]. For details about the change of parts, please contact our agent.
