## STEERING GEAR SERVICE NEWS

No.: E8-18-007

### **SUBJECT : Case Example of loss of Steering Ability Due to Looseness of the Connector for LVDT in E type Steering Gears**

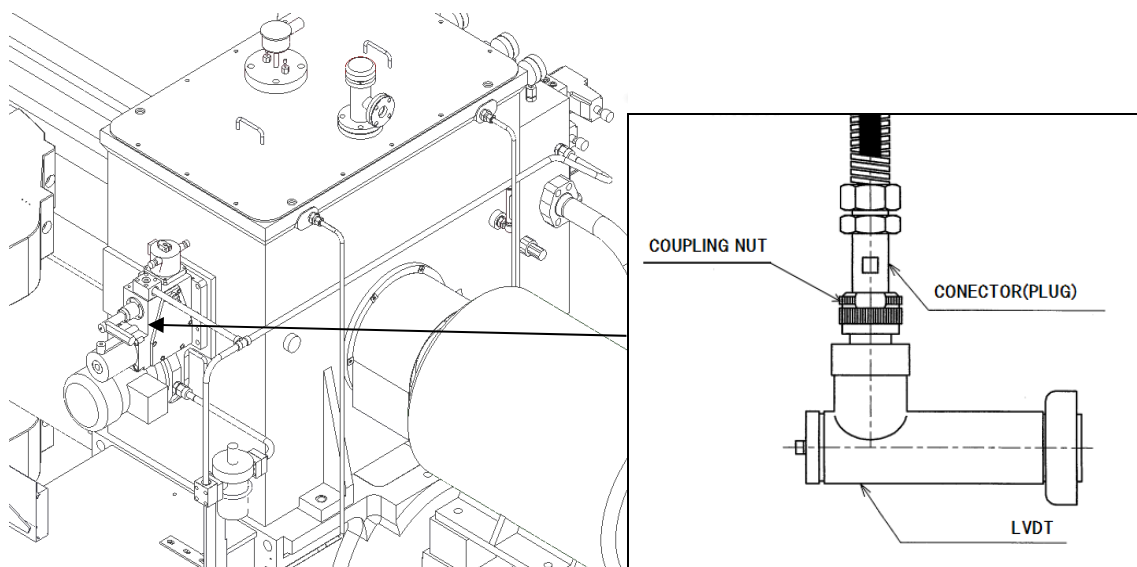
In the model RE/FE type steering gear, when the COUPLING NUT of the cable connector of the LVDT which is the sensor for monitoring the operation of the regulator performing the pump control becomes loose, contact failure may occur, the signal cannot be normally sent to the autopilot, and the ship may fall into an uncontrollable state. Since this part is not a moving part, it will not loosen easily if tightened properly using a tool such as a spanner. On the other hand, when tightening is performed without using a tool, sufficient tightening torque cannot be obtained and the possibility of loosening by vibration increases.

For safe navigation of the ship, also check the loose of the connector part at the inspection every 3 months described in the periodic inspection in the instruction manual, and make sure that there is no abnormality in the operation of the steering gear (tightening torque of COUPLING NUT is  $3.92\text{N}\cdot\text{m}$  as guide). We recommend making match mark on the relevant parts with a marker pen etc., and managing so that you can easily observe loose connectors.
