**STEERING GEAR SERVICE NEWS**  
(KAWASAKI ELECTRO-HYDRAULIC STEERING GEAR)

NO.:E8-02-002  
ISSUE: May,08,2003

**SUBJECT : Maintenance of solenoid valve for unloading device**

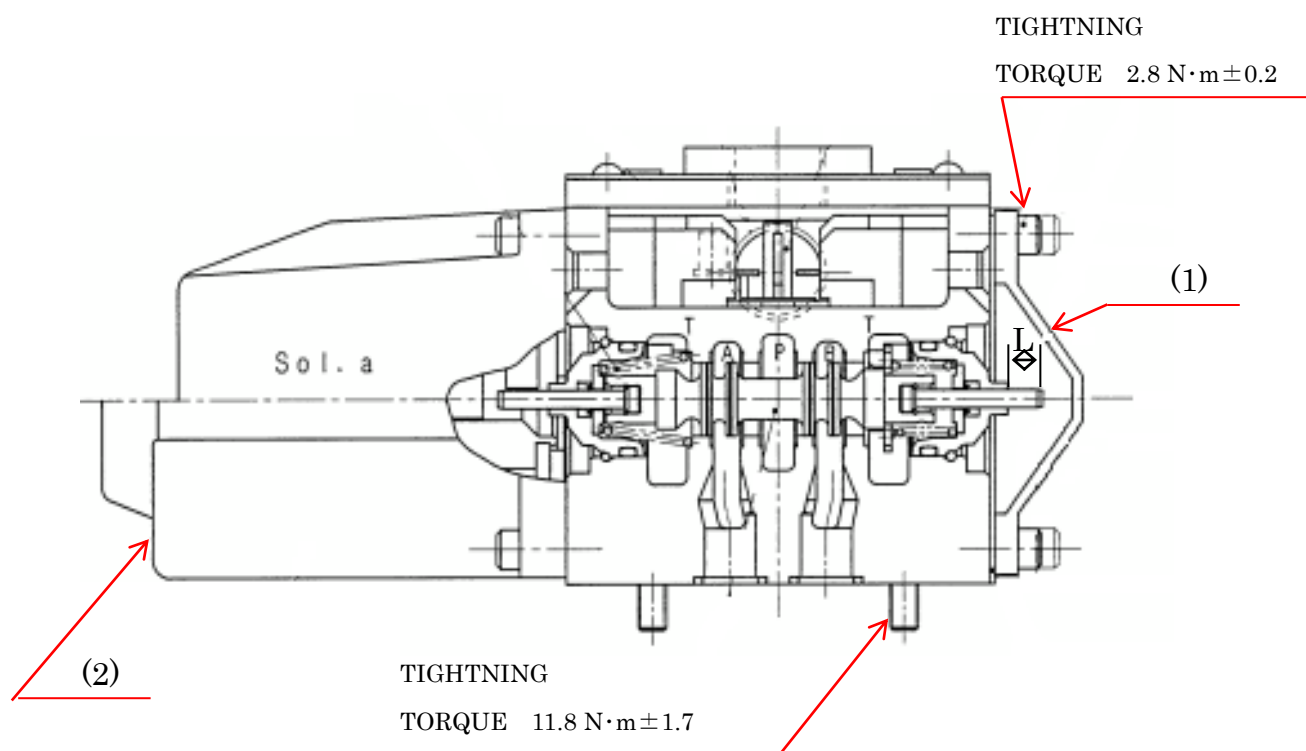
Solenoid valve for Unloading device

- 1) Remove the cover(1) which is right side of the solenoid valve.
- 2) Confirm the “L” length of the push-rod is abt.6mm while the solenoid(2) is de-energized (Sol. OFF).
- 3) Confirm the “L” length of the push-rod is abt.9mm while the solenoid(2) is energized (Sol. ON) by means of starting the electric motor.
- 4) Confirm the push-rod is moved to correct position smoothly with repeating Sol. ON and Sol. OFF a few times.

- 1) Make it sure that the power of the hydraulic power unit is turned off and that the electric motor has completely stopped before starting work.  
You must also confirm the system pressure has dropped to zero.
- 2) Remove the solenoid(2) which is left side of the solenoid valve.
- 3) Check the push-rod for such as any rust.
- 4) If it rusts. re-assemble it temporary after removing the rust by a nylon brush and applying the push-rod with working oil. Then replace it promptly.

- 1) Apply the push-rod with working oil.
- 2) Install the solenoid(2) and cover(1) in the original position by specified tightening torque( $2.8 \text{ N} \cdot \text{m} \pm 0.2$ ).
