Kawasaki Heavy Industries, Ltd.

Notice of Series N700 Shinkansen Train Bogie Frames matter

Series N700 Shinkansen Train Bogie Frames

Explanatory Material for Manufacturing of Bogie Side Frames for Series N700 Shinkansen

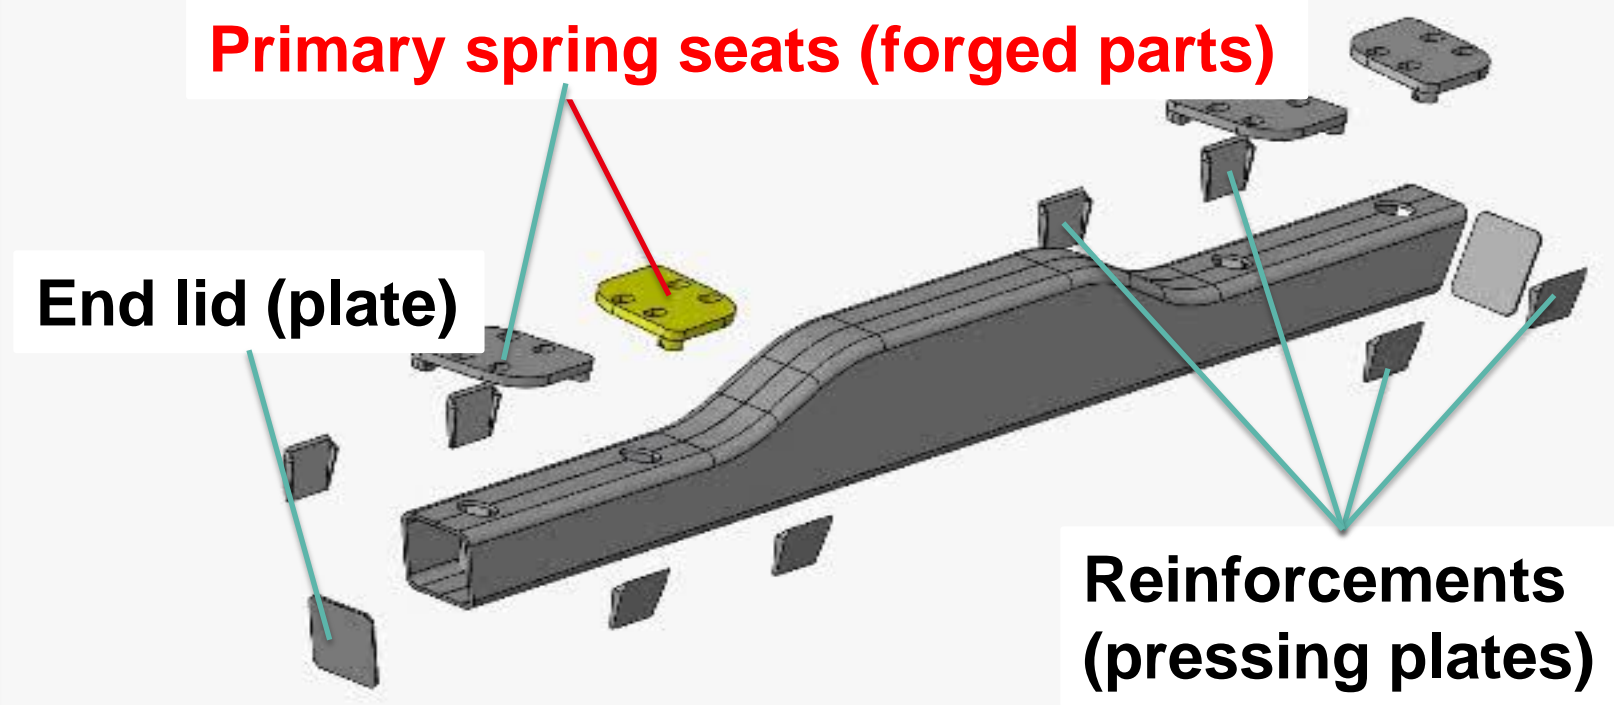
Welding Attachment of Parts to Side Frames

Through the investigations, analysis and modeling until now, it is considered that a fissure caused by some factor including the welding process existed. This fissure as a trigger point propagated faster by effects of the thinner bottom plate of the side frame and developed the crack of the Failed Bogie Frame. Also there is a possibility the deposit welding across the entire primary spring seat gave an adverse implication.

Defects in Adjustment Work during Attachment of Parts to Side Frame

When the primary spring seats were attached, the bottom plate of side frame was not even and was ground off to adjust the gaps between the side frame and the primary spring seat to 0.5mm.

- (1) Regarding the series N700 bogie frames that we manufactured to the same specifications as the Failed Bogie Frame, we will replace the bogie frames with thinner the bottom plate of the side frame less than 7mm in thick with new ones. We will also replace the bogie frames where, as a result of ultrasound testing, there might exists an internal flaw in consideration of our defects during manufacturing process.
